Claire Blanché Kim White Flood damaged road infrastructure: Can a rapid response be effected within the parameters of South Africa's environmental legislation?

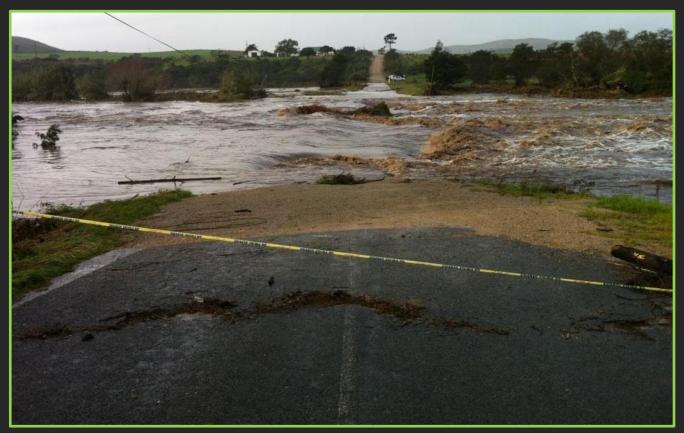
Typical flood damage to the gravel road network infrastructure includes:

• Washaways of bridges and low-level causeways

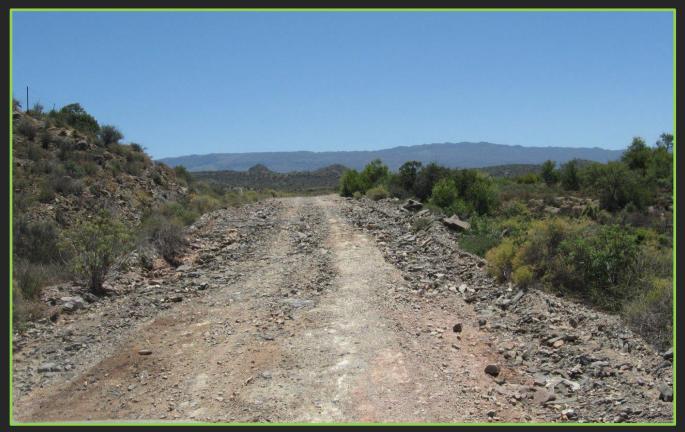
Typical flood damage to the gravel road network infrastructure includes:

• Washaways and erosion of gravel road surfaces

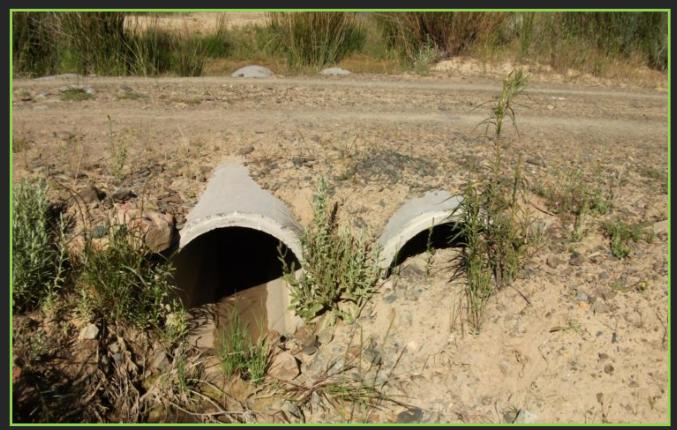
Typical flood damage to the gravel road network infrastructure includes:

Damage to, blockages of, and sedimentation of stormwater infrastructure such as mitre drains, pipes and culverts

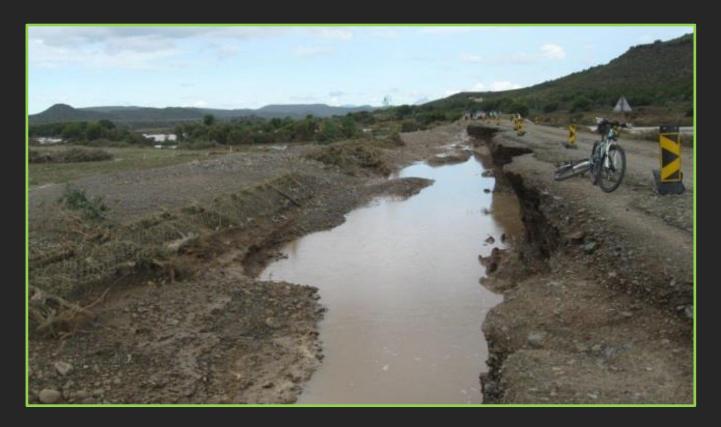
Typical flood damage to the gravel road network infrastructure includes:

• Slumping and slipping of road embankments or layerworks
