# The Development of a Detailed Wetland Management Guideline for the Halfway House Granite Dome

Johan van der Waals

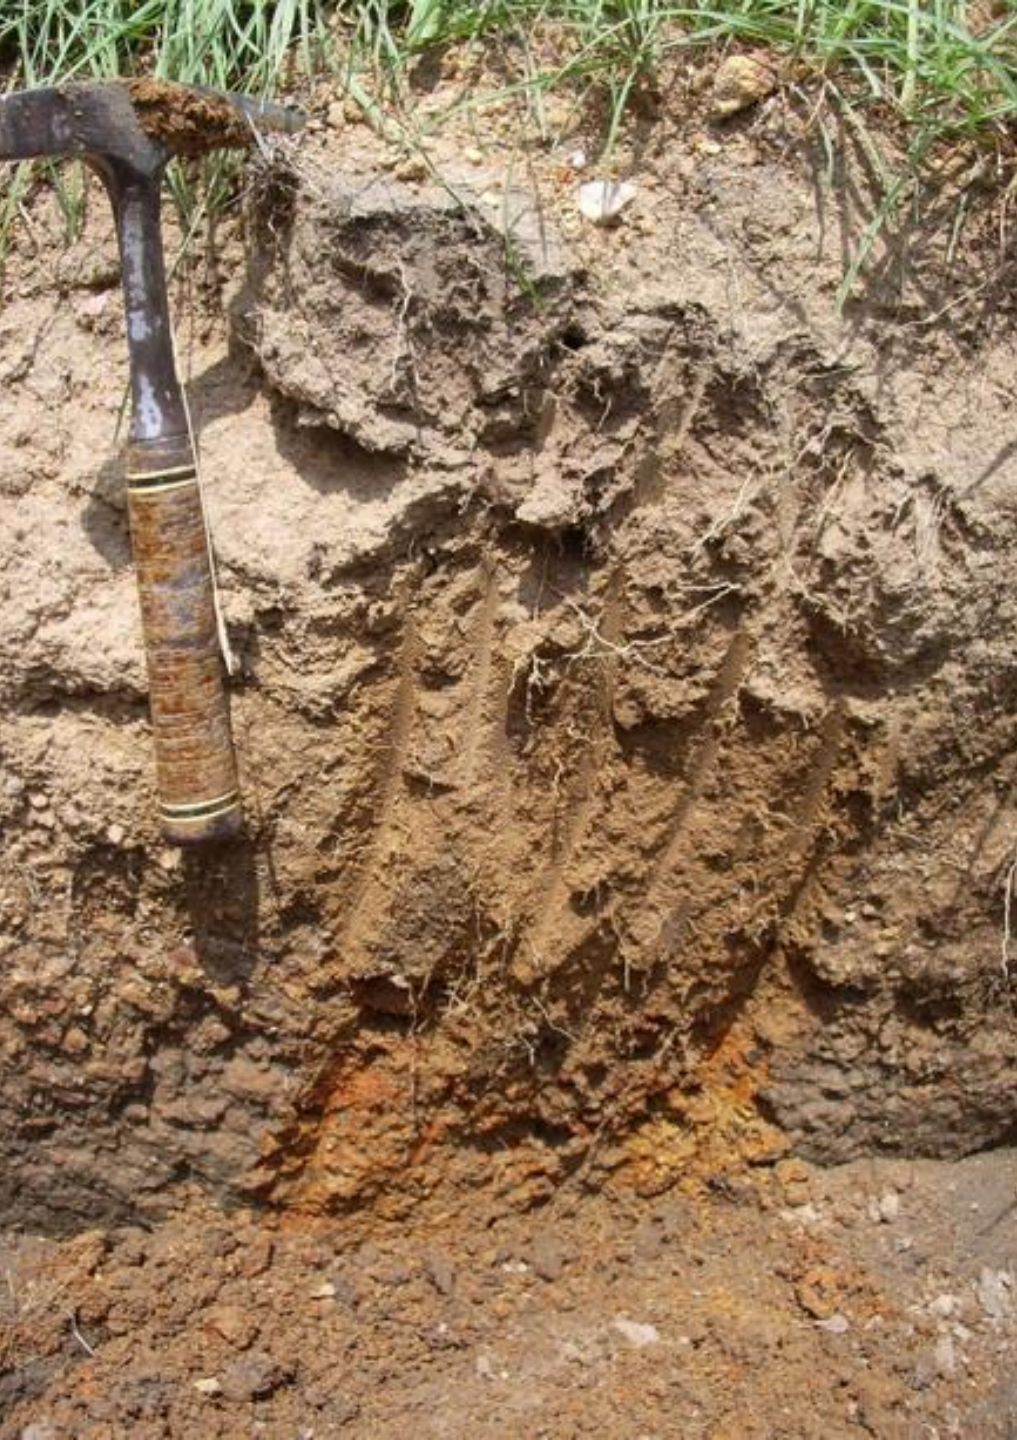
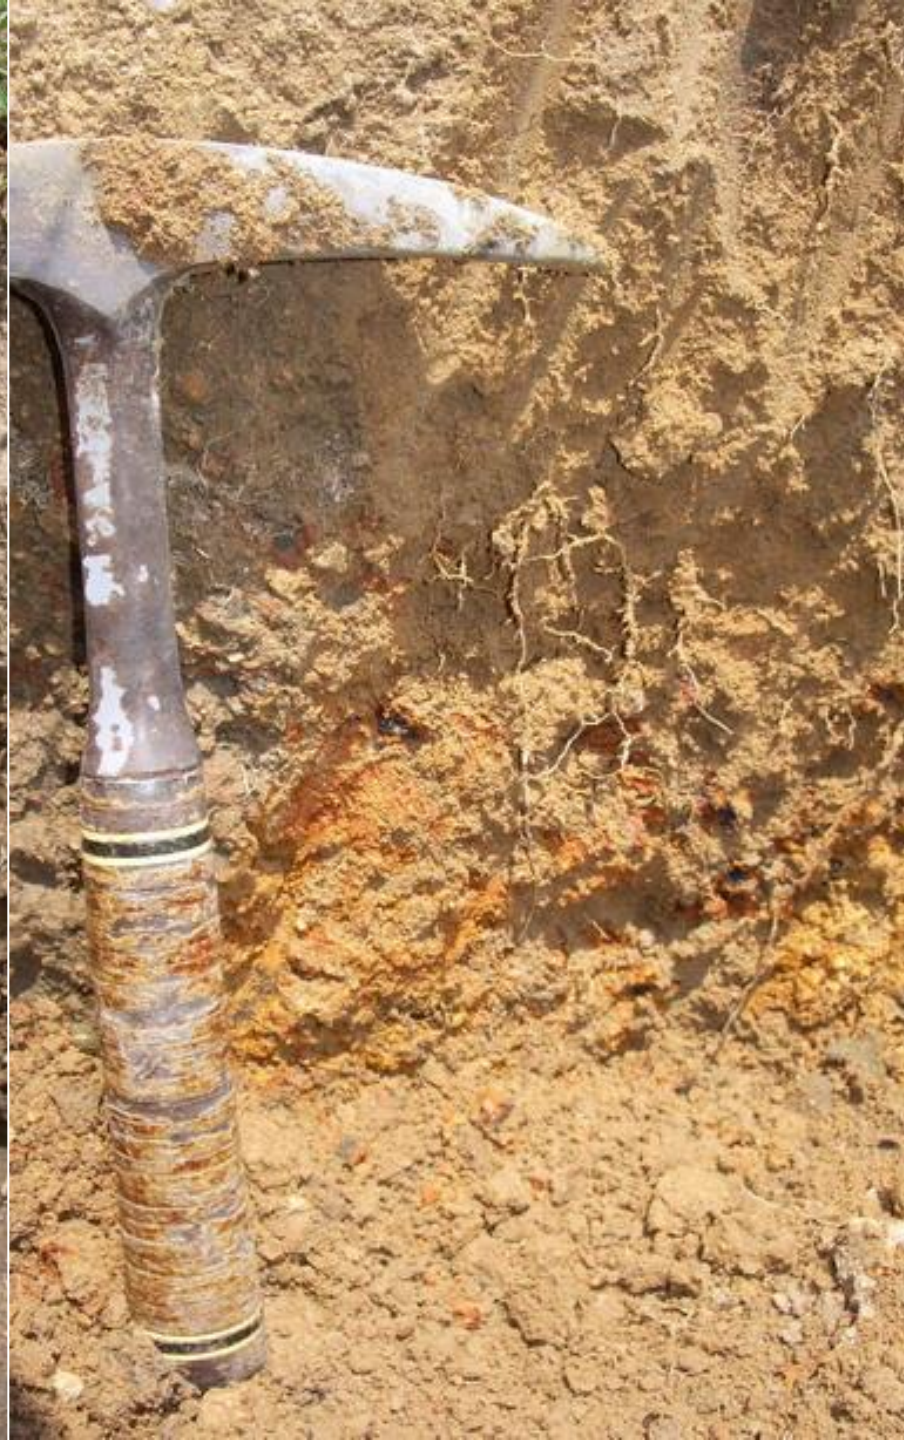
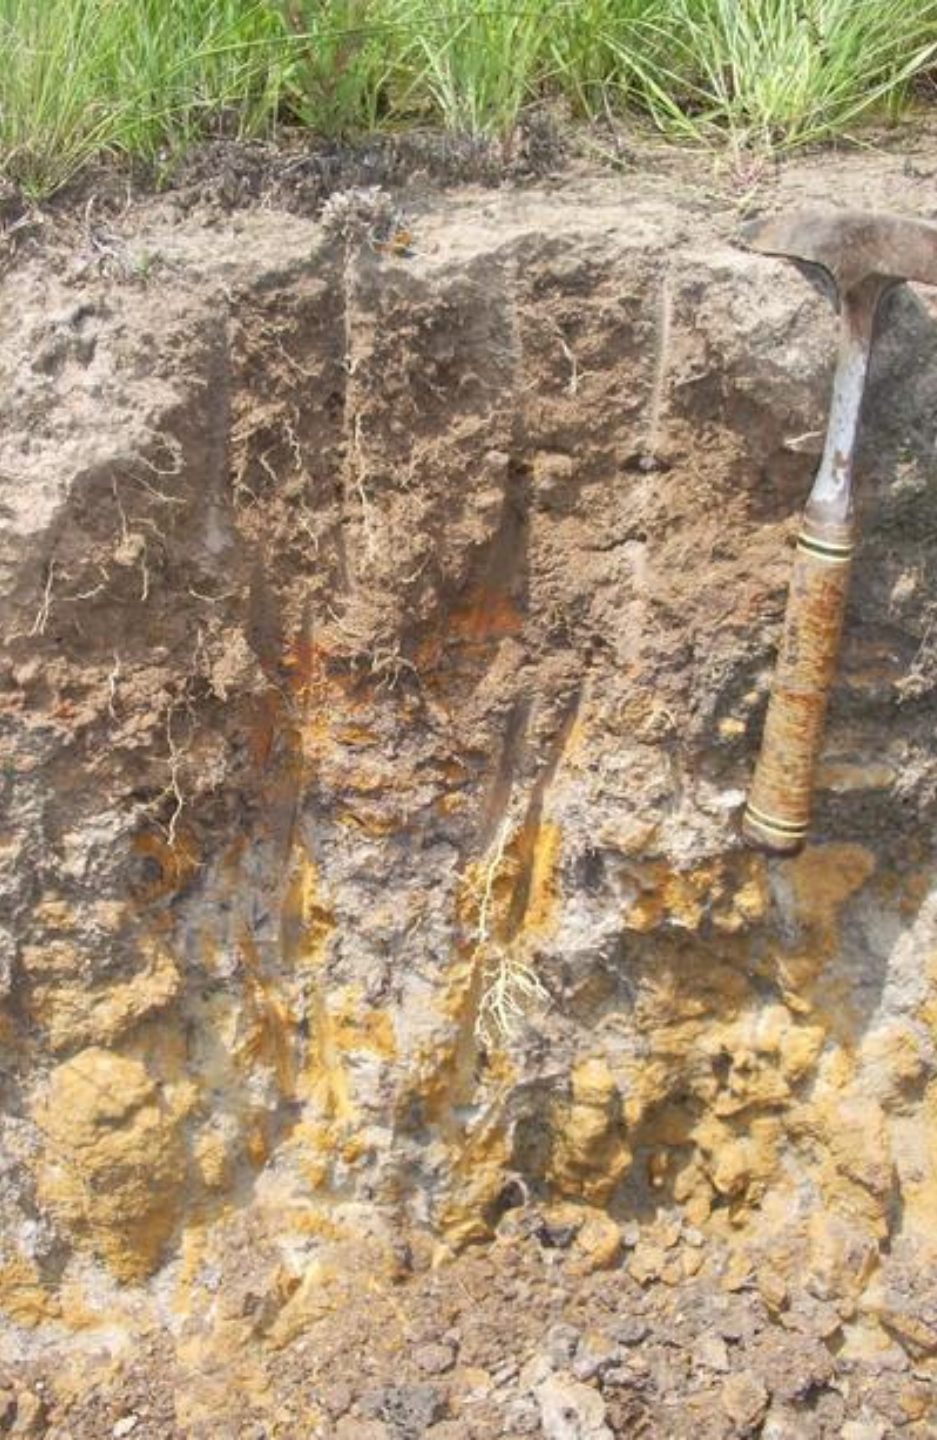
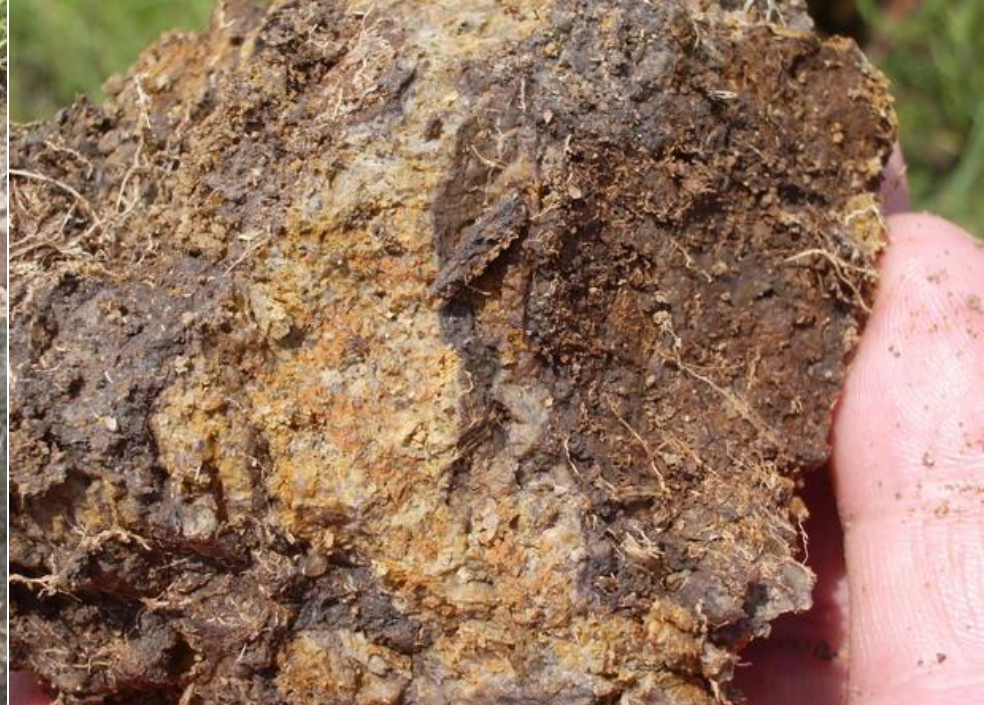
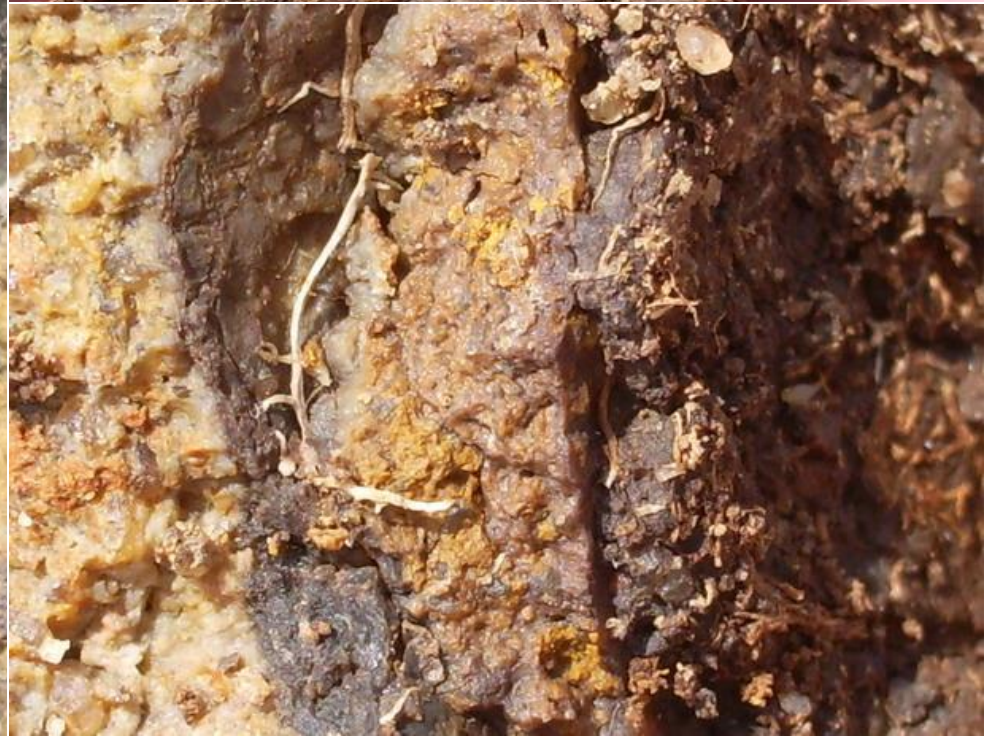
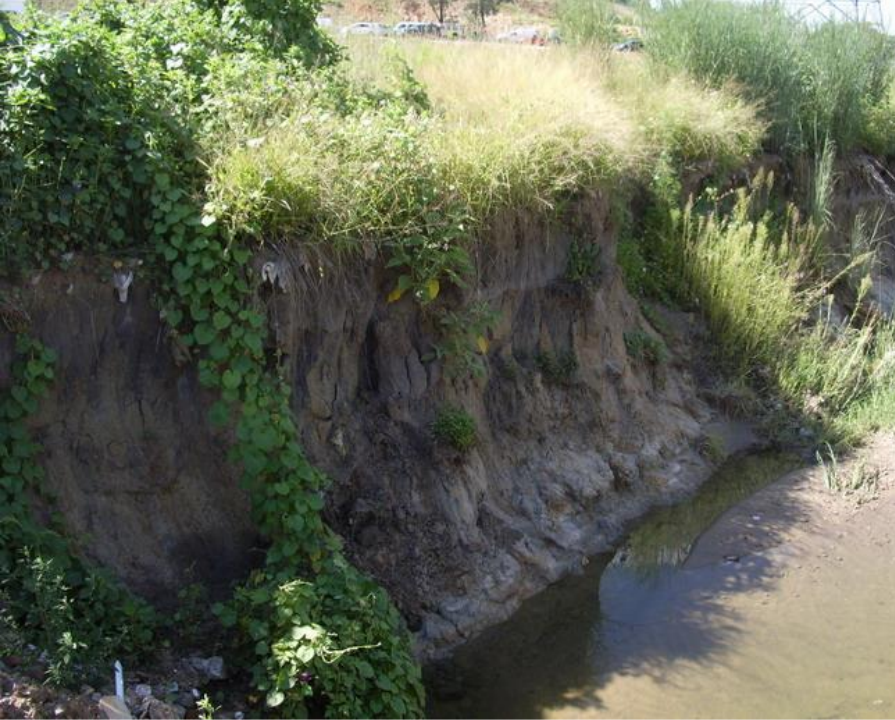
# Anatomy of a Wetland Disaster

- Wetlands on the HHGD cannot attenuate floods!
- Wetlands are in equilibrium with natural conditions (before human impacts)
- Erosion sets in with runoff increasing by as little as 5 %
- The wetland soils are:
  - Dispersive due to dominant clays
  - Often sandy with no cohesion between soil particles
  - 100 to 500 % more erodible once saturated with water
